## Maintaining Software for Active Missions: a Case Study of Chandra's CTI Problem

**Abstract.** During early flight operation, the Chandra X-ray Observatory's Advanced CCD Imaging Spectrometer (ACIS) suffered degradation of charge transfer inefficiency (CTI) due to radiation induced charge trapping. The ACIS front-illuminated detector CTI has significantly degraded over time with respect to the intrinsic energy resolution of the chips. In this presentation we use the degradation of CTI in the ACIS camera as an example of how software was adapted to fix a significant and unforeseen post-launch problem in on-board hardware. We will discuss the impact of CTI on events, RMF and gain files. Then, we will discuss the software updates necessary to alleviate the degradation effects and to improve spectral resolution. Finally, we will highlight other ACIS hardware problems and their corresponding software solutions.

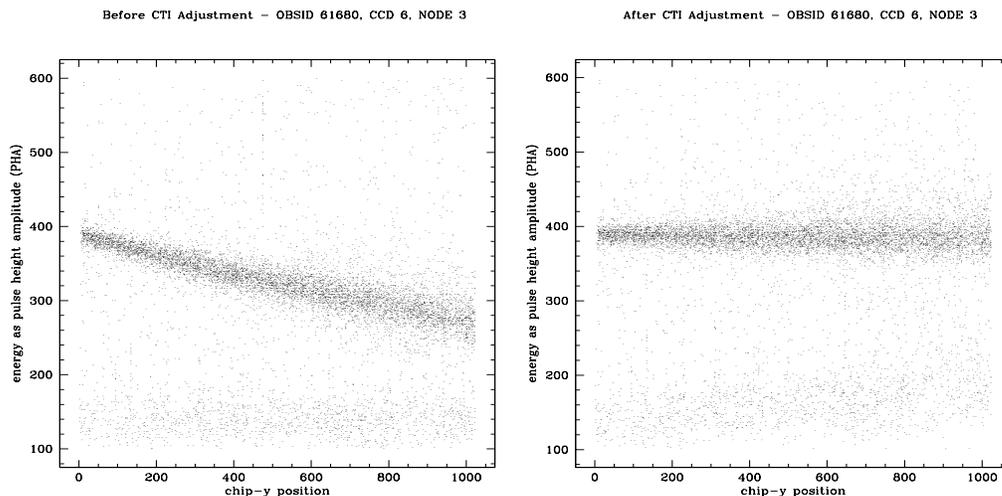
Figure 1. Energy plots across a CCD before (left) and after (right) the CTI correction.

Shortly after the launch of the Chandra Observatory, the ACIS detector (one of two primary science instruments) suffered severe degradation to its charge transfer inefficiency due to soft proton damage, resulting in loss of energy resolution and the elimination of some events that would otherwise be considered good.

*Tools* The core event processing tool that computes energies and performs coordinate transformations was changed in order to incorporate a correction algorithm developed by teams at Penn State and MIT. The algorithm estimates the amount of charge deposited on a CCD for an event based on the amount of charge read out and the location of the event on the detector. New parameters were added to the tool to make use of new calibration files and for controlling when to implement the algorithm. The CTI adjustment reverses nearly all of the apparent gain shift and can significantly improve the energy resolution of a detector. The grating event processing tool also had minor updates to handle new calibration files.

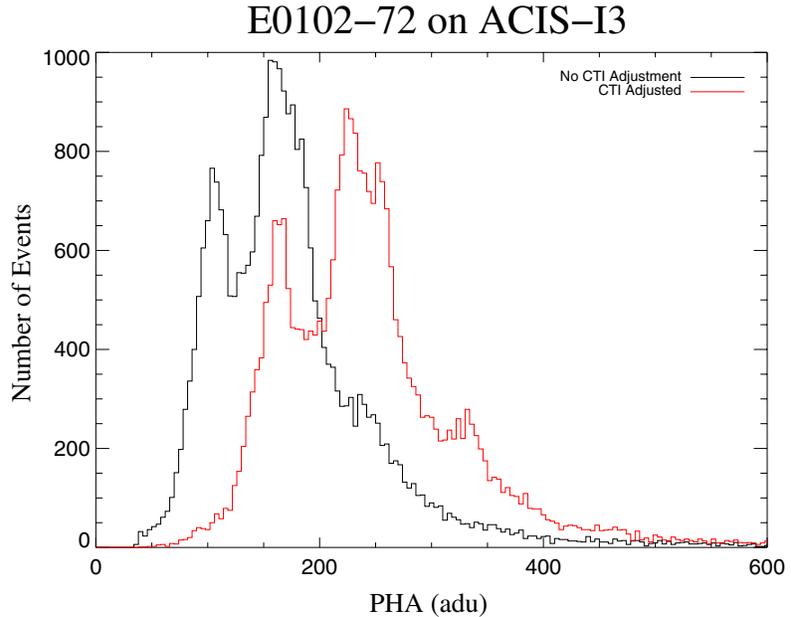
*Gain Shift* The amount of charge read out from an event will be less than the amount of charge deposited on the detector. The difference in charge will depend on the number of pixels crossed before reaching the read-out node. Thus, the loss of charge at the top of the chip will be greater than when charge deposited near the read-out node. The pulse-height distribution for a source will be shifted to lower energies and result in an apparent gain shift.

Figure 2. An energy spectrum before and after the CTI adjustment.
